Horn Ring repair [Die-Cast]

Die-cast Repair

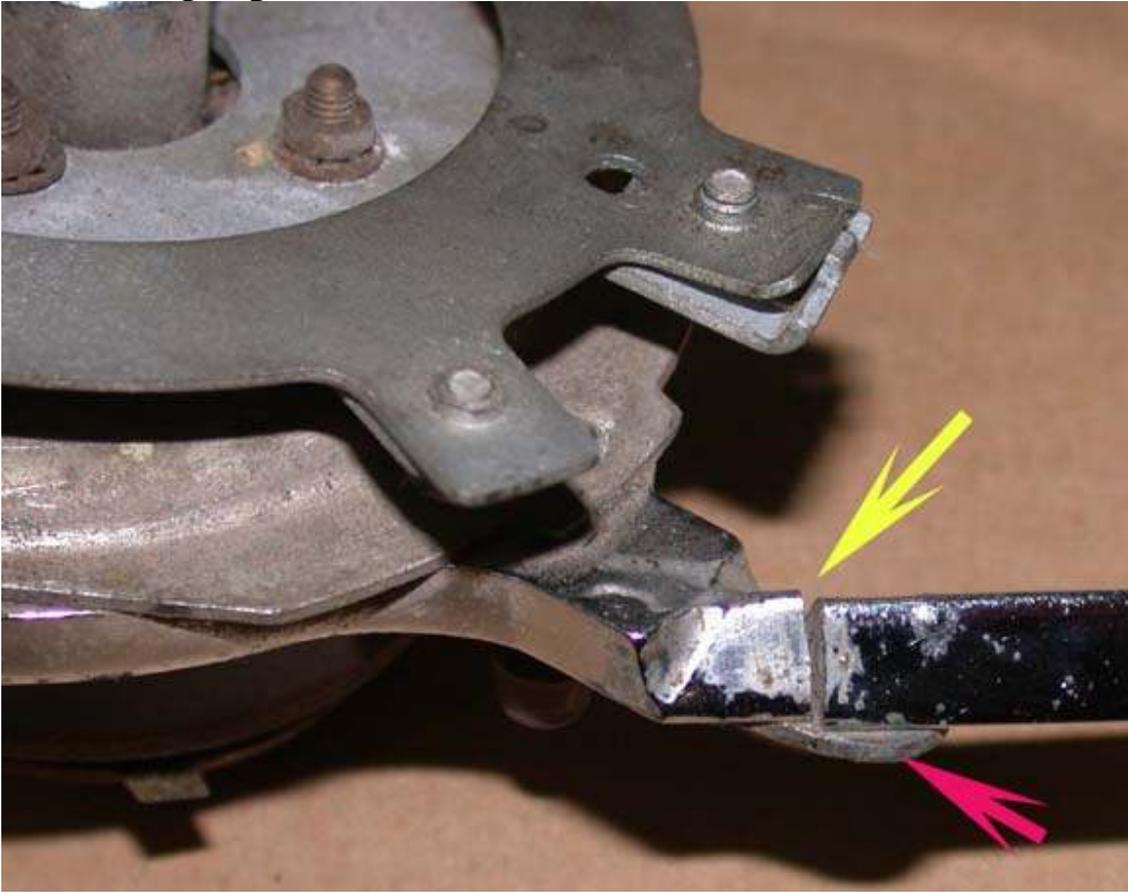
Picture 1. Broken Horn Ring – note previous repair using a bridging plate

Definition-Spoke. For the purposes of this article the three parts that radiate from the inner hub to join the outer ring have been called spokes. Picture 1 has a broken spoke.

Products in die-cast can come back to life, **picture 8**, although it seems increasingly difficult to find materials, experience and electroplaters for the resurrection to happen. Keep in mind die-cast in our 1950's cars is a mix of metals that attacks itself, causing both cavities and blistering over a period of time. Blistering can be seen in **picture 1**.

- Examine the original and check its all there and justifies repair
- Remove anything that can be, and have a plater strip it of chrome
- Examine on return; it should now be bare die cast or covered in copper
- Prepare areas to be welded by cleaning only the surface
- Hold in clamps/jig in such a way as to maintain its normal shape

- Use an oxidizing oxy flame for heating
- Fill or weld work area with the flux-less Cromweld Zinc welding rod no. 321671
- Once parent metal is melted adjust the heat to maintain control
- Build weld area in excess of its final shape [No flux used with No. 321671 rod]
- Allow to cool and file [or/and use a Dremel as its very hard] to reshape to original
- After reshaping the horn ring can be outsourced to refinish and chrome, or alternatively prepare faults/imperfections yourself and ask plater to electroplate in copper and then fill faults/imperfections with solder
- Once smoothed give to plater for finalisation and chroming
- In addition. Studs located in the central steel plate can be soldered at their rivet end if found to be loose. See pictures No3 & No5.

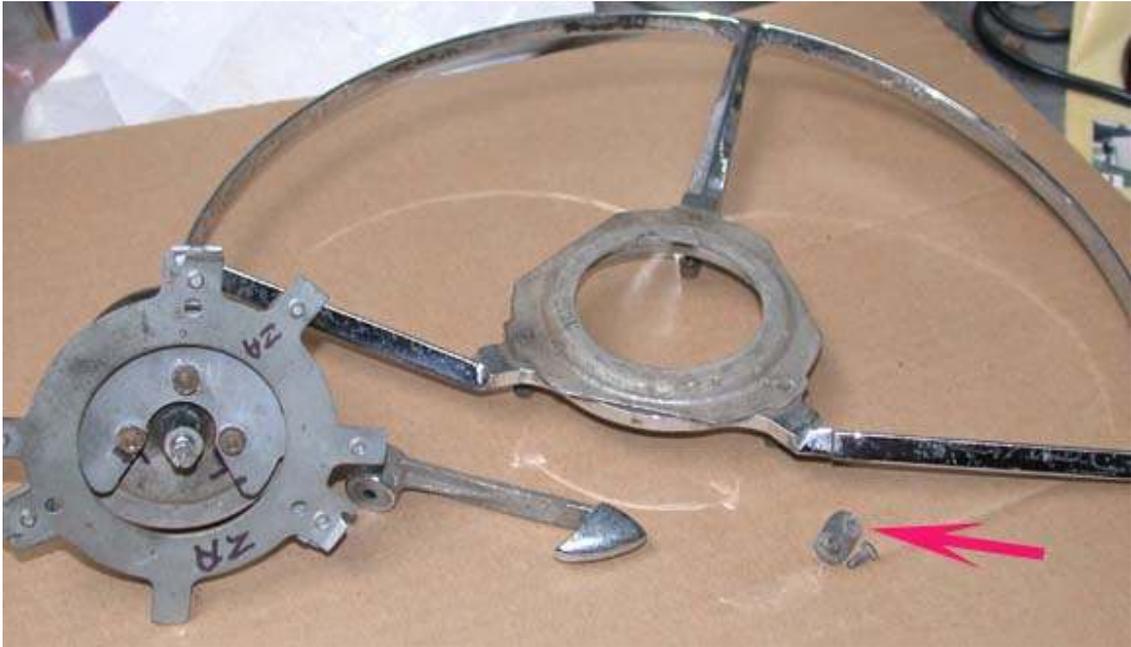
Picture 2. ZA horn ring with attachments taken off [bridging/repair plate removed]

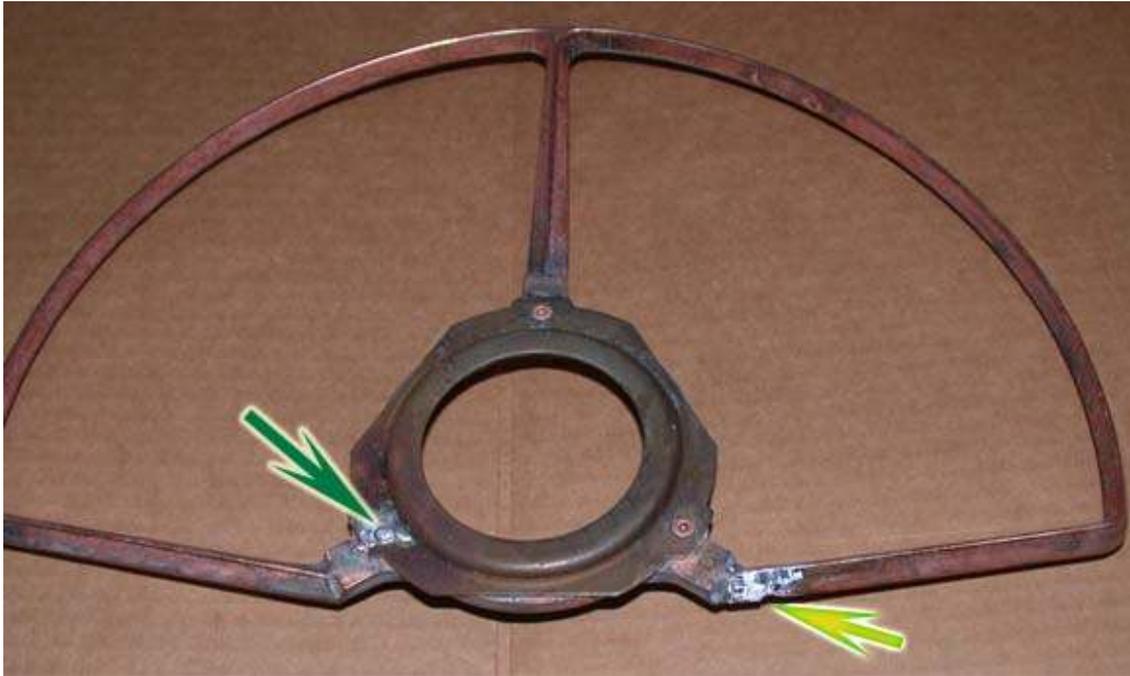
Picture 3. Initial repairs to spoke and soldering of loose rivet on left

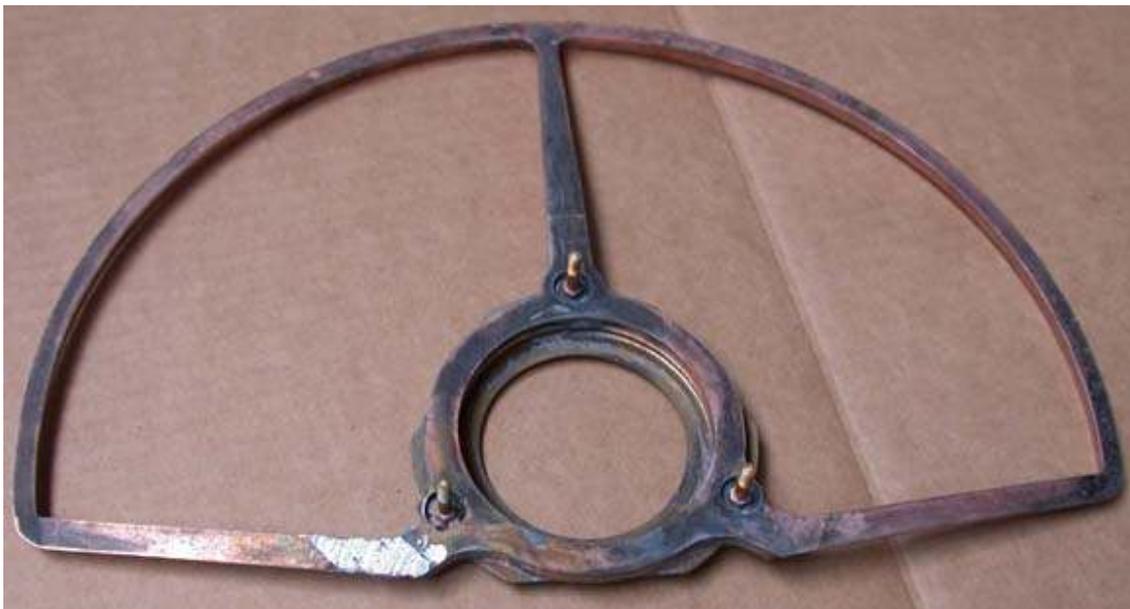
Picture 4. Underside repair. Note the three studs, they are riveted from front.

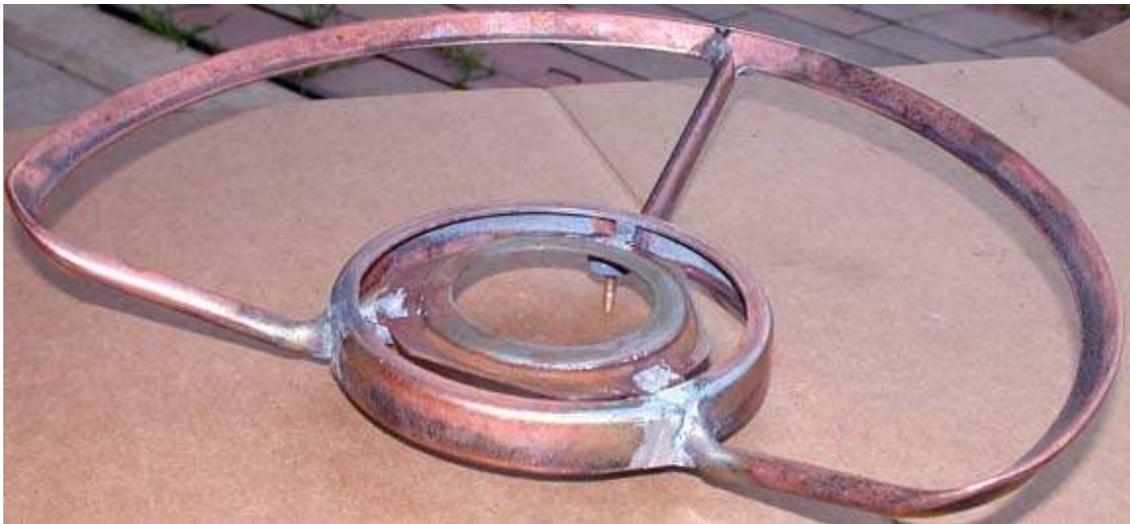
The ZB horn ring had met with some misfortune in a previous life, being distorted around the circular support ring and fractured close to a connecting spoke.

Straightening the *support ring connecting the three spokes caused the existing fracture to break completely [picture 5] and develop a further fracture near the [picture 6] left spoke. Next two pictures show progress of this repair.

**Definition – Support ring. The ZB horn setup has been simplified to include an inner ring in its hub construction/casting and for the purposes of this article is now called the support ring. Picture 5 shows support ring repair in progress.*

Picture 5. ZB Horn Ring. Shown on right is repair of major break in the support ring

To again emphasize, it's important to hold the item being repaired in such a way as to re-establish the original shape, and maintain that shape during welding.

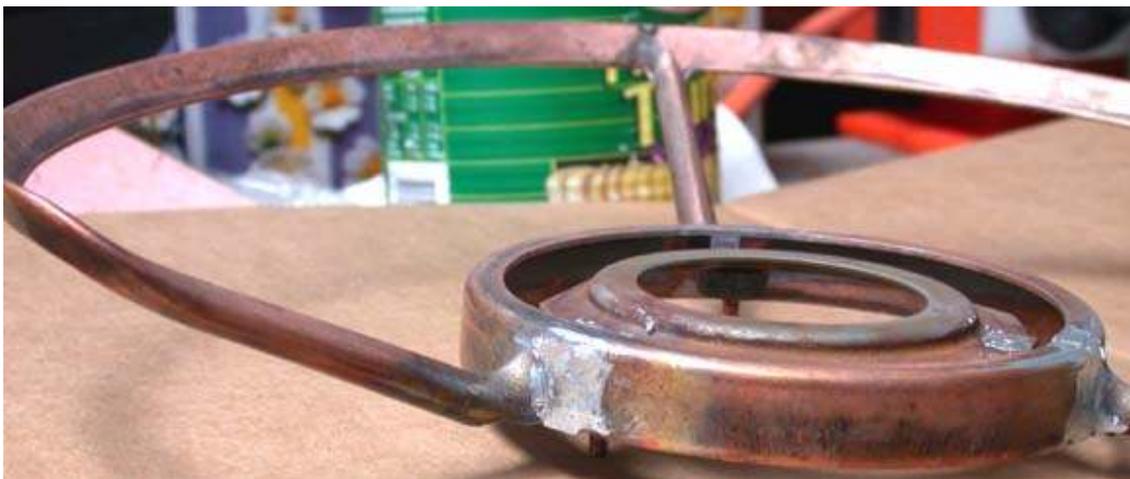
Picture 6. ZB Horn Ring. Shown on the left is repair to the fracture in the support ring

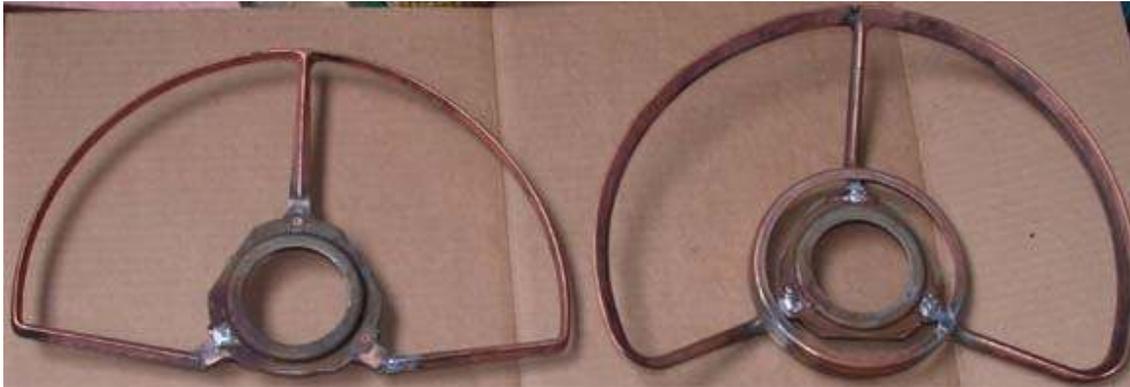
Picture 7. ZA and ZB Horn rings after initial welding of die cast and soldering of rivets

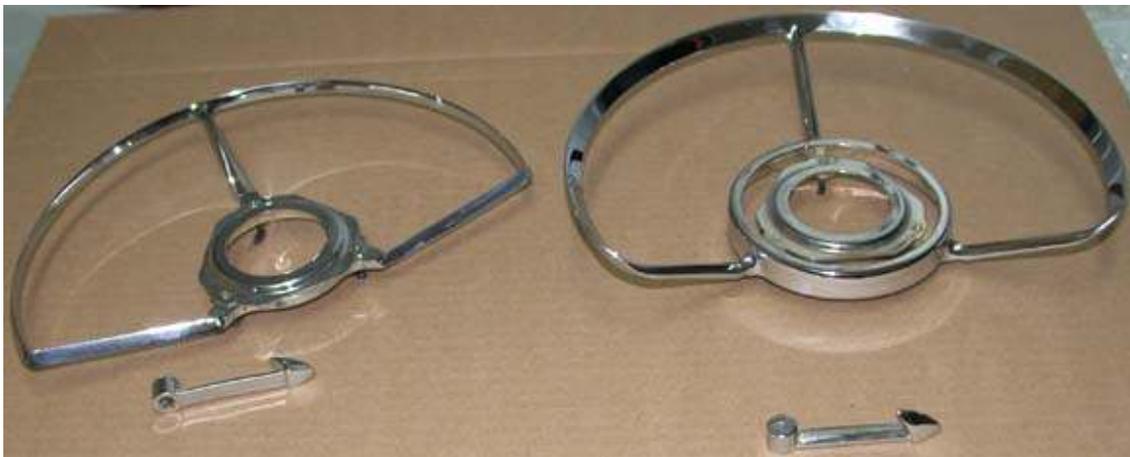
Picture 8. ZA and ZB horn rings back from re-chroming
