Wiper Arm Pivot Shafts and Link Rod (Fig. 17)

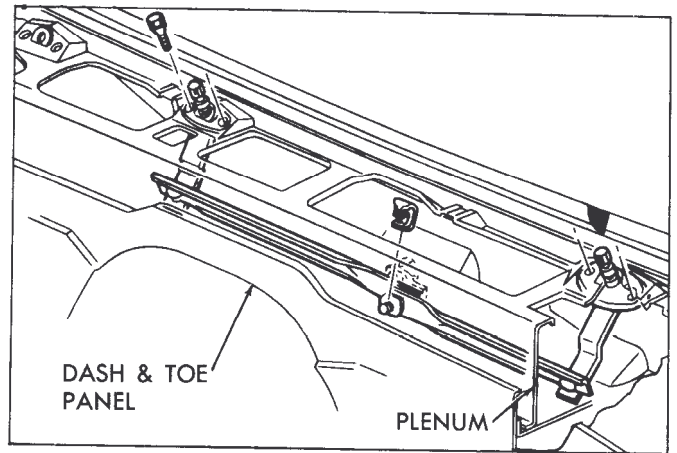
Fig. 17—Windshield Wiper Linkage

1. Remove windshield wiper arms from pivot shafts. Procedure for removing arms is explained previously under "Arm Adjustments."
2. Remove screws which attach outside air cowl ventilator grille to cowl. Carefully remove grille forward from cowl.
3. At center of cowl, remove retainer (fig. 17) which attaches each link rod to motor drive linkage and arm assembly. Disengage link rods from pins.
4. Remove two screws which attach arm transmission

pivot shaft assembly to cowl. Remove pivot shaft assembly with link rod from plenum chamber.

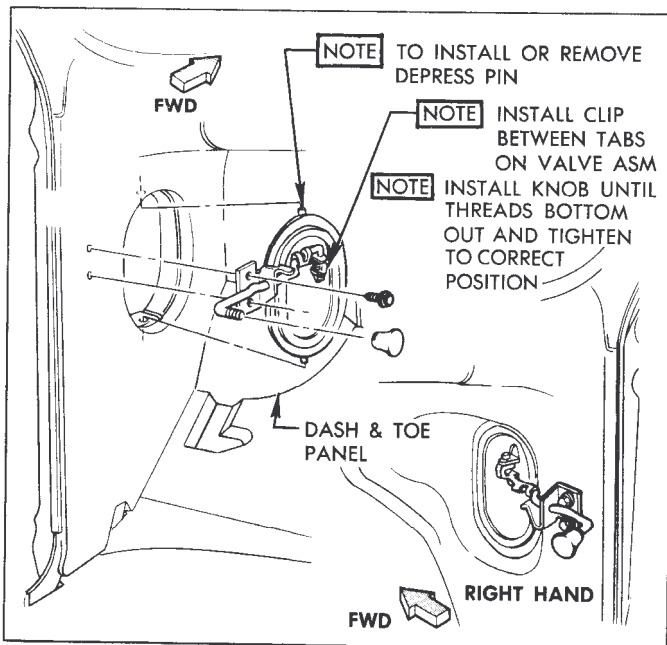
Fig. 16—Cowl Air Ventilator Valve

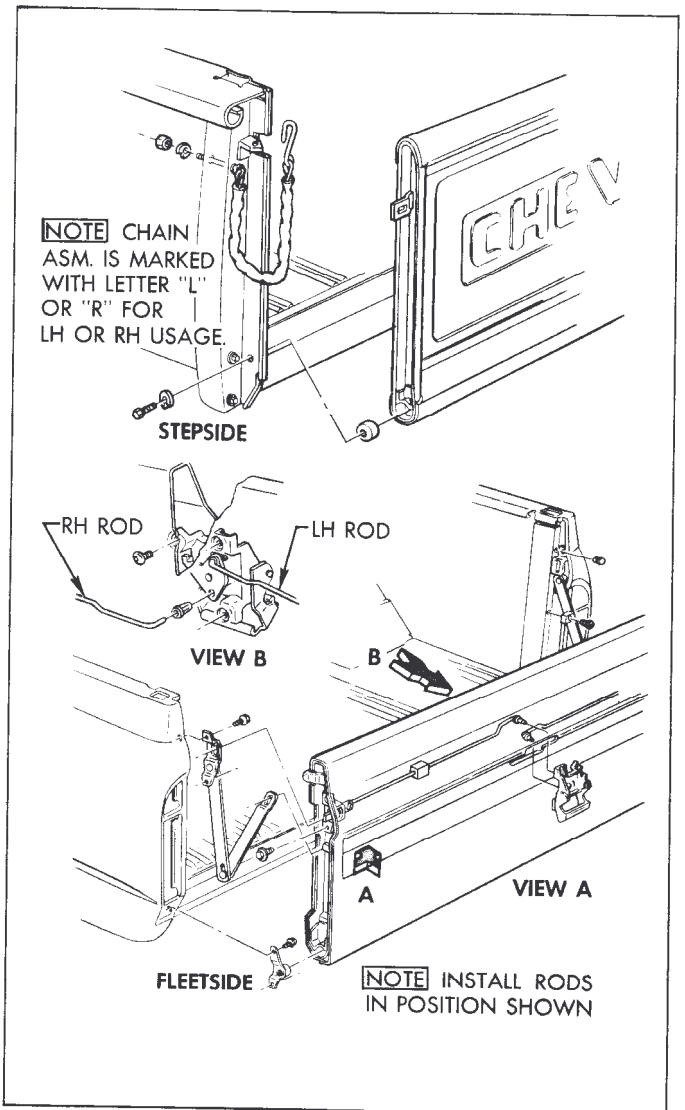
Fig. 18—Endgate - Stepside and Fleetside
